**DEPARTMENT OF FORESTRY AND FIRE PROTECTION**

November 11, 2020

Since October 28<sup>th</sup>, 2020, CALFIRE Forester Scott Bullock and I have been inspecting portions of the Timber Operations that your contractors/Licensed Timber Operators (LTO's) have been conducting since August of 2020. I am in receipt of your letter dated November 4, 2020. What I do agree with is that it's critical for CAL FIRE and PG&E to work together to help the utility come into compliance with numerous environmental regulations and prepare the ground you have been operating on since the fire for winter.

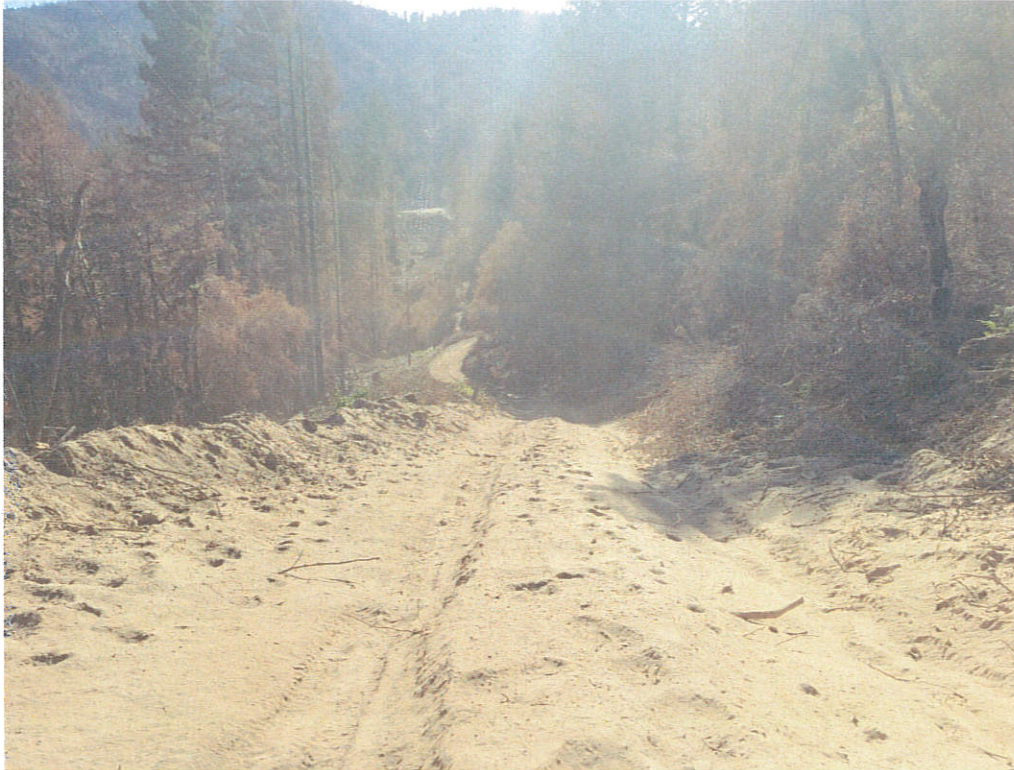
Not watering seasonal roads on your operations is a common issue that we continue to observe. We see roads watered in one section one day with frequent use by your crews and no water truck returning for several days and other roads that don't appear to ever get watered. This has resulted in the loss of integrity of the road surface and excessive buildup of dust which is a significant source of sediment during initial rainfall events. We have observed this on just about all seasonal private roads associated with this operation. This is a violation of 14 CCR §§ 923.7(c). In addition to lack of maintenance of the road surface, lack of waterbar installations or cleanout of rolling dips was observed. As this is after the start of the Winter Period, this is a violation of 14 CCR §§ 916.6(a).

**Photo taken 11-4-2020 by S. Bullock Photo Point SB-2. Shows lack of road watering and waterbars on seasonal road. Note, this road segment is on Big Basin Water Co. Lands in the Boulder Creek watershed above numerous water intakes and Coho and Steelhead habitat.**

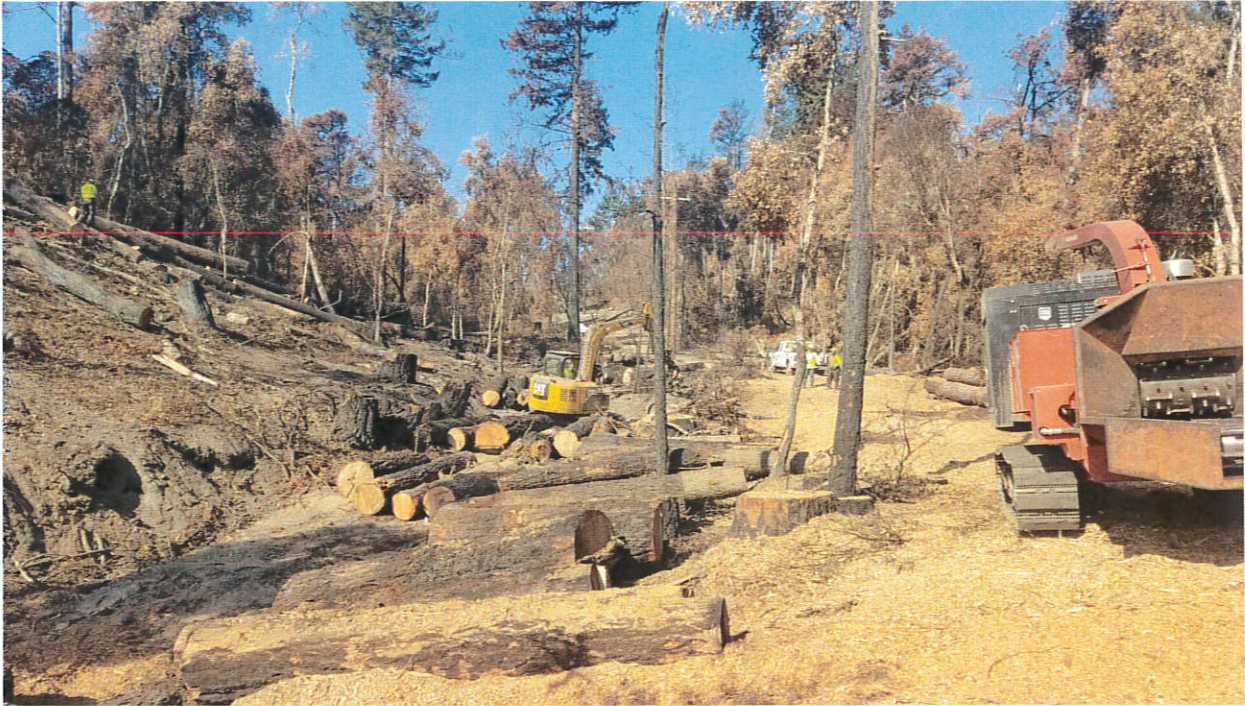
On October 30, 2020 I observed Mountain Enterprises Inc. equipment working on the westside of Swanton Road on the hill north of the Scott Creek Bridge near the old School House. The powerline parallels what appears to be a Class III watercourse for 150 yards. The current road is under the powerline and an old road bed is just west of it in a draw. Drainage has been diverted in the past into the old roadbed away from the new road and a channel has formed.

This channel meets the definition of a Class III watercourse and drains into Scott Creek 800' below. I observed evidence of runoff at this location following the slight rainfall this past weekend that transported sediment into Scott Creek which is a Class 1 stream. I observed logs deposited in the Class III channel and an excavator working directly in the channel. In discussions with the crew, they told me that they had not received any direction about dealing with the watercourse including a decision to either remove or stabilize the debris in the channel. This is a violation of both 14 CCR §§ 916.4(c)(1) and (3). It should be noted that this site is within the Coastal Zone.

**Photo taken 10-30-2020 by R. Sampson. Photo point RS-2. Shows operations in a Class III drainage.**

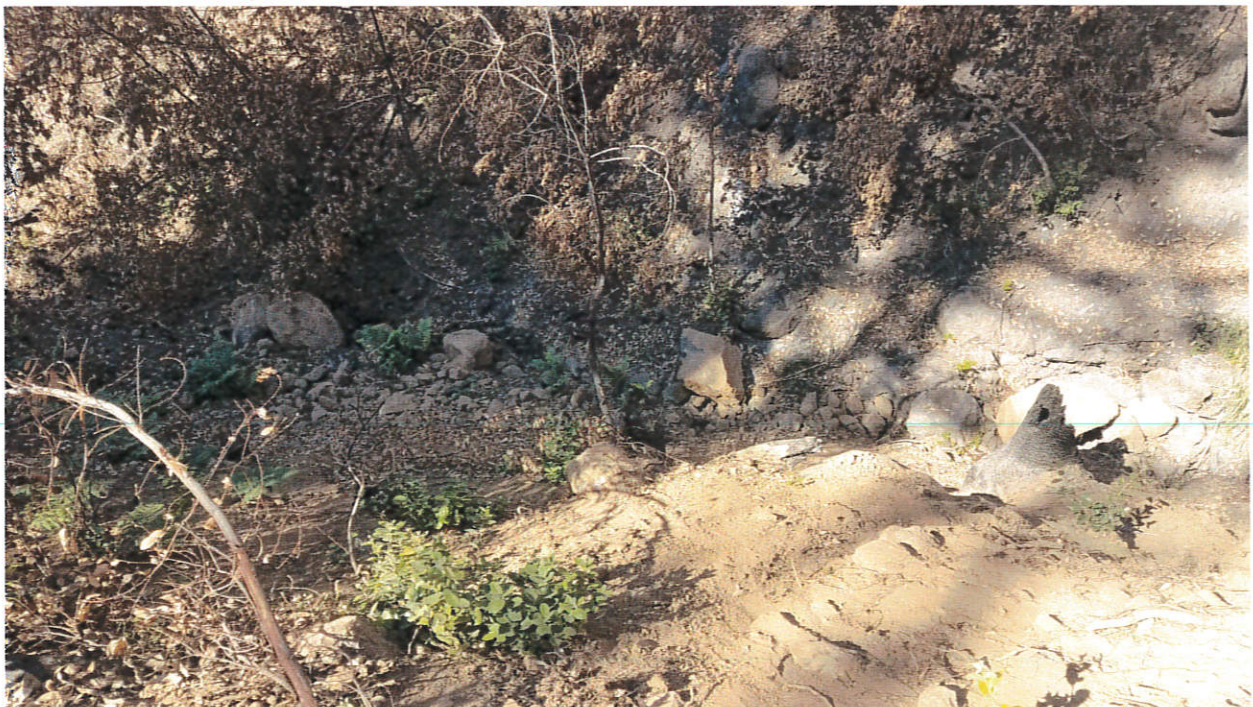
On October 30, 2020, while on the Redtree Properties LLC THP (1-18-179-SCR), I observed soil and debris deposited directly into Hyman Creek, a Class II drainage. Included in the grading project was a short (100') spur road on 50% slope leading to a new powerpole installed as part of the transmission line repair following the fire. The spur road had no waterbars or other drainage, was surfaced with loose fine soil and as graded storm runoff would drain down its entire length directly into Hyman Creek. There was no evidence of erosion control work at this site which normally would include removal of the soil from the stream channel along with straw or waterbars on the spur road. This is a violation of 14 CCR §§ 916.3(b).

**Photo taken 10-30-2020 by R. Sampson at Photo Point RS-3. Shows dirt and rocks from grading project on transmission line deposited directly into a Class II channel.**

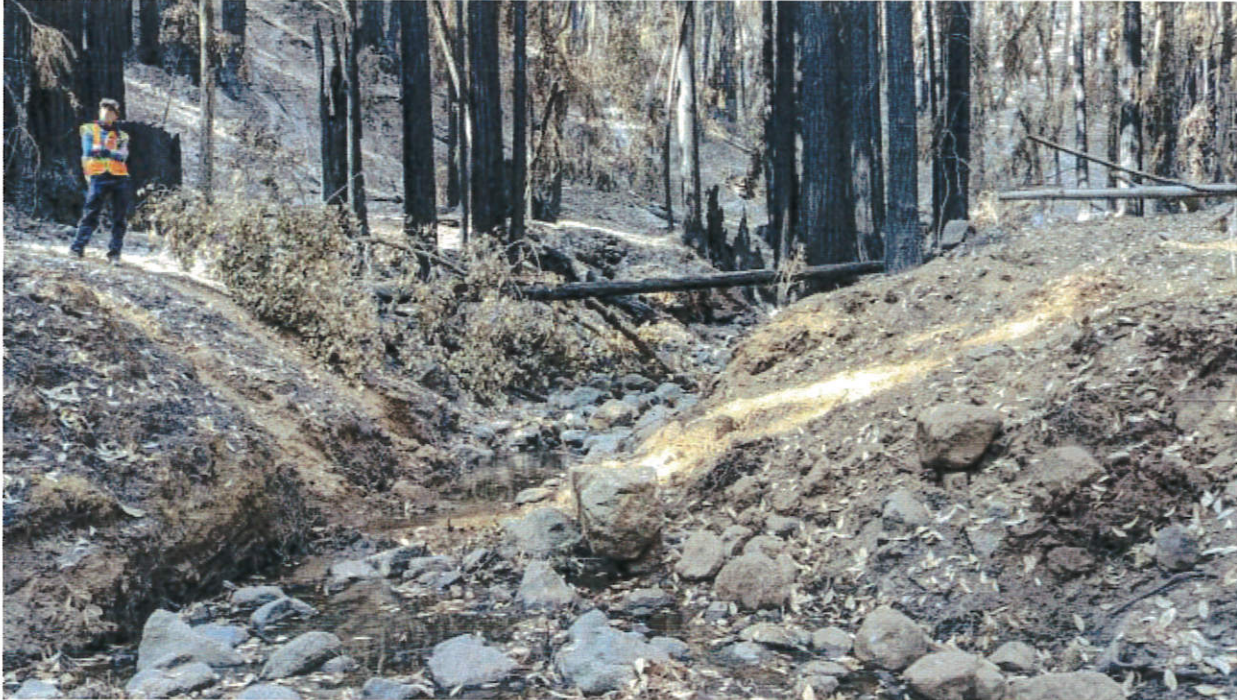
During the period where active fire was burning in the San Vicente Creek area, I received reports of a crossing of San Vicente Creek, a Class I fishery, by a large tracked vehicle, possibly a bulldozer, by a PG&E contractor working to repair the transmission line. I received a photo from the Land Owner (San Vicente Redwoods, Nadia Hamey) showing evidence of that event (See below). Hamey told me that she took that photo when meeting with PG&E representatives to discuss how they were going to mitigate the damage the utility was responsible for.

**Post fire photo at Photo Point RS-4, taken by RPF Nadia Hamey. Shows track marks of equipment crossing of San Vicente Creek.**

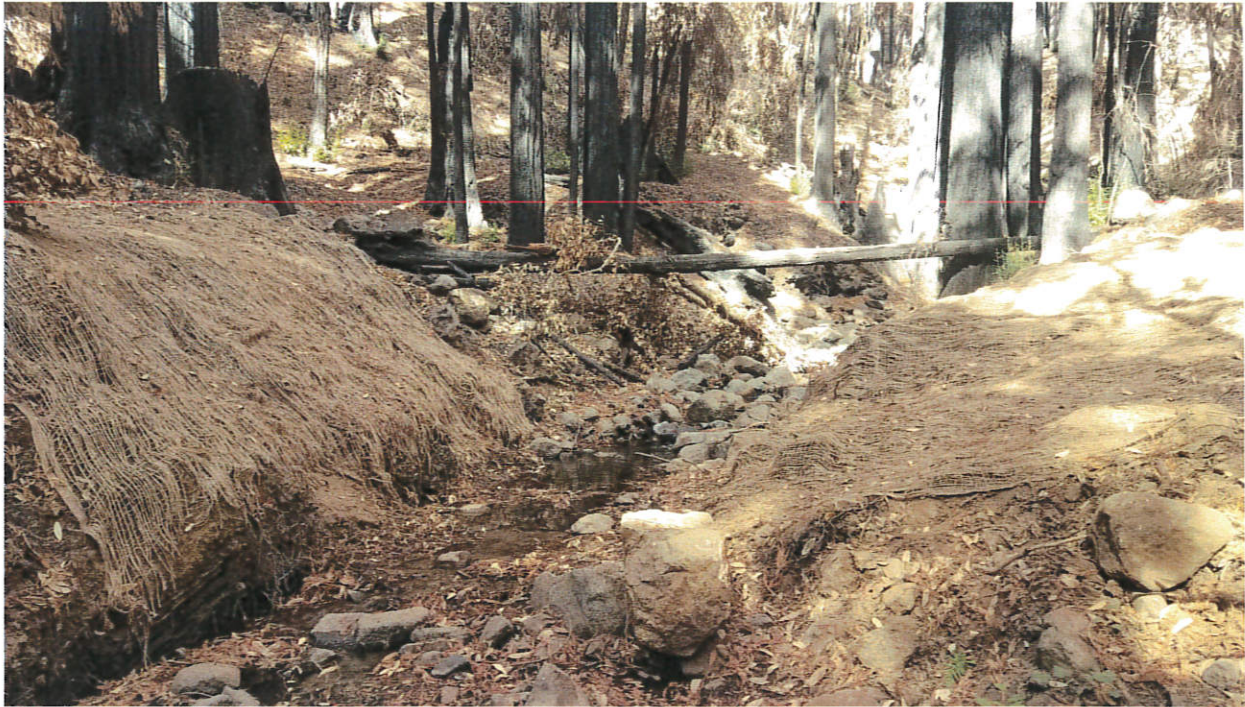
On Friday November 7, 2020, I drove to that crossing and observed evidence of the unpermitted crossing. I also observed that some erosion control efforts had occurred to attempt to mitigate the damage to the creek and banks. I was able to observe evidence that a large tracked piece of heavy equipment had crossed through the creek and appeared to be going from east to west. This is a violation of 14 CCR §§ 916.9(e)(1), operations within a channel zone. It appeared that soil had been removed from the crossing evident in the earlier photo and that a single layer of Jute netting had been placed on the banks of the stream at the crossing site.

I recognized this site as an old abandoned crossing from an inspection I made for a THP in approximately 2003. At that time the RPF's for the 2 THP's I was inspecting told me that they were working with PG&E to stop any more use of that crossing and a restoration effort was included in those 2 plans to abandon this road. It appears to me that all of the mitigation work conducted in 2004 for those plans and over 15 years of recovery has been negated by this violation. That stream is not only a fishery but also serves as the water supply for the town of Davenport. All of this damage is within the Class I WLPZ for the current THP prepared by the landowners.

In addition, I saw evidence that the efforts to mitigate the recent damage to the watercourse were inadequate given current conditions at the site. Both approaches to this crossing are tractor roads on steep slopes with loose soil resulting from excessive use by heavy equipment without soil stabilizing measures. The amount of heavy equipment activity that occurred at this site since the fire has generated a deep layer of fine sediment that is perched upslope from this Class I watercourse.

**Photo taken 11-6-2020 by R. Sampson. Photo point RS-4. Shows tractor crossing of San Vicente Creek after previous corrective work. Note extent of jute netting only 15' each approach and bare soil not covered at base of left (west) approach.**

The hand dug waterbar on the west approach to the crossing is less than 4" deep and given the length and steepness of the skid trail above, that one stand alone, substandard waterbar is not adequate given conditions and events I've observed at that location during past winters. The eastern approach has deeper loose soils with poor drainage extending up the tractor trail for over 200'. I saw little to no filter capacity for the expected runoff. Standard protection measures required by the rules would require several waterbars that were at least 12" deep and straw mulch or slash packing to provide coverage from the channel out to the edge of the WLPZ boundary (100') on both sides.

PG&E shall provide a plan with a schedule for completion for a more appropriate level of protection for this unapproved Class I crossing of San Vicente Creek. This work should be coordinated with California Department of Fish and Wildlife and Regional Water Quality Control Board staff for any required permits from those departments.

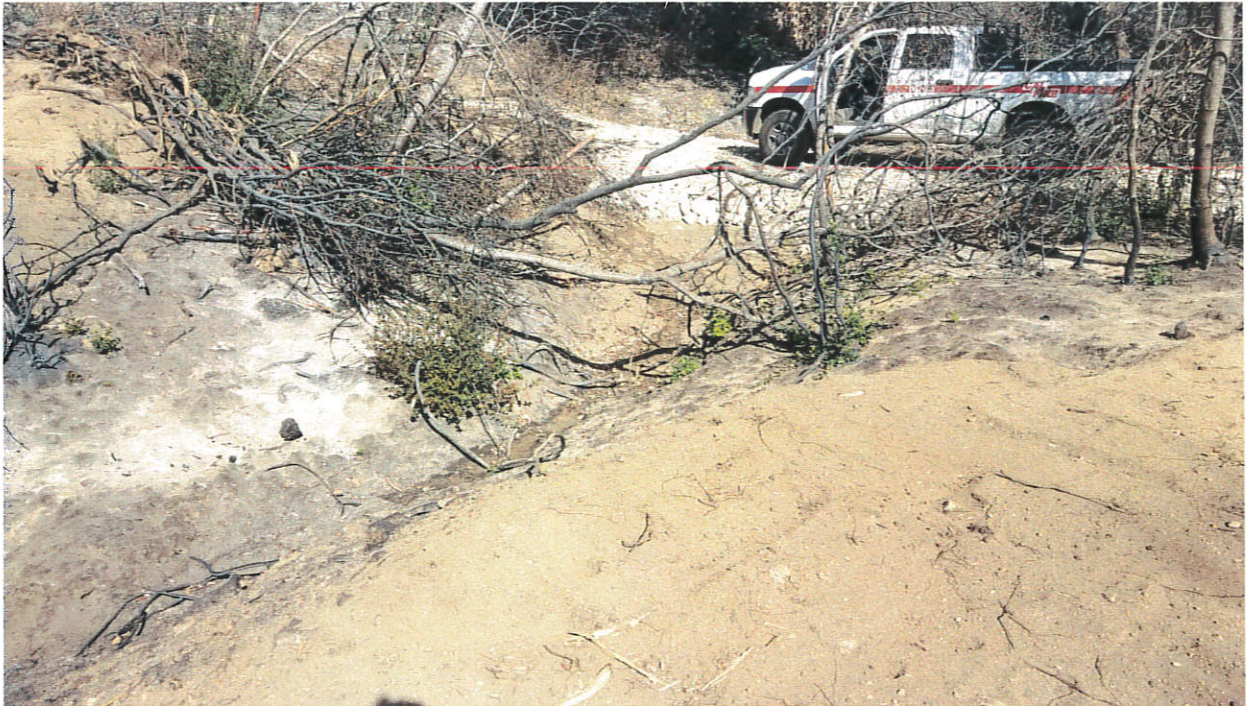
The PG&E Burns – Lonestar Transmission line parallels the west side of Empire Grade Road between its crossing of San Vicente Creek by Los Robles Road and a point where it crosses Empire Grade north of Camp Ben Lomond. Along that line the road had been regraded and numerous sections have fill perched adjacent of above watercourses. As the winter period started on October 15<sup>th</sup>, and there was more than 30% chance of rainfall on the day this was inspected (November 6, 2020) this is a violation of both 14 CCR §§ 914.6 and 916.9(n)

**Photo taken 11-6-2020 by R. Sampson. Photo point RS-5 looking east upslope. Shows Class III drainage with new rocky crossing but lower right is uncontrolled bare filled created during operations. Drainage across this fill (see next photo) is all directed down its length into the watercourse channel without breaks or filter.**

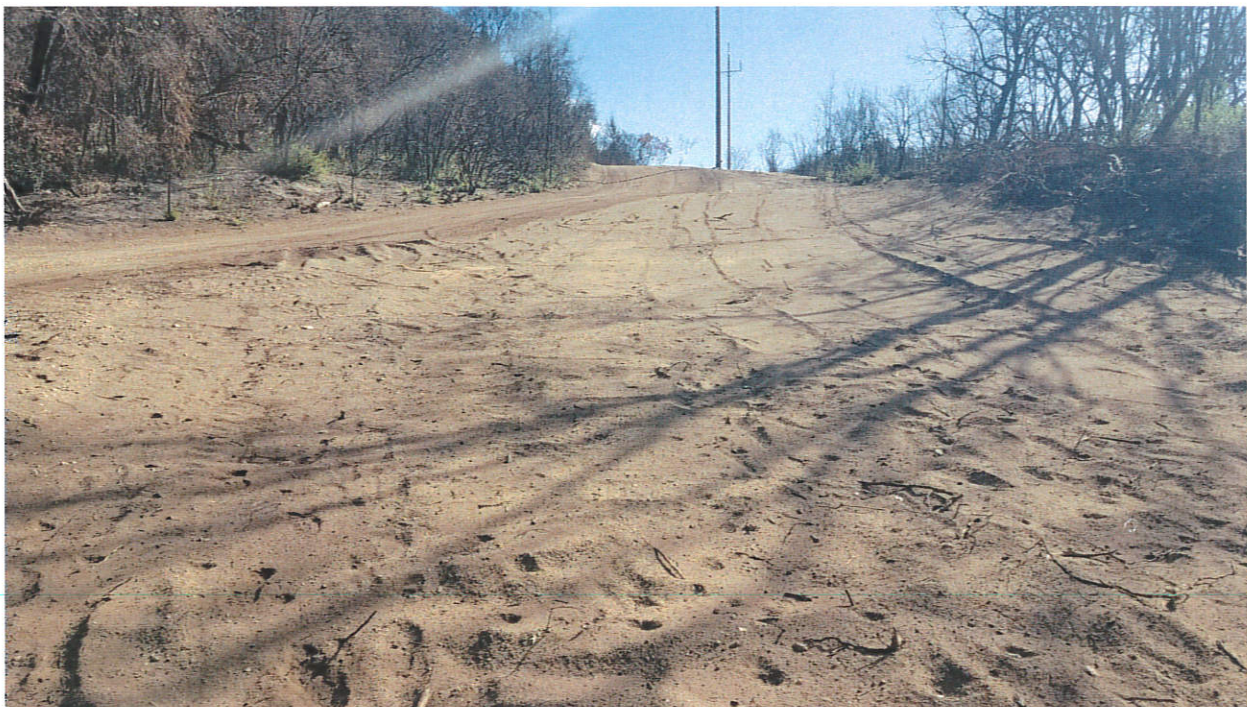
**Photo taken 11-6-2020 by R. Sampson. Photo point RS-5 looking south along the ROW.**

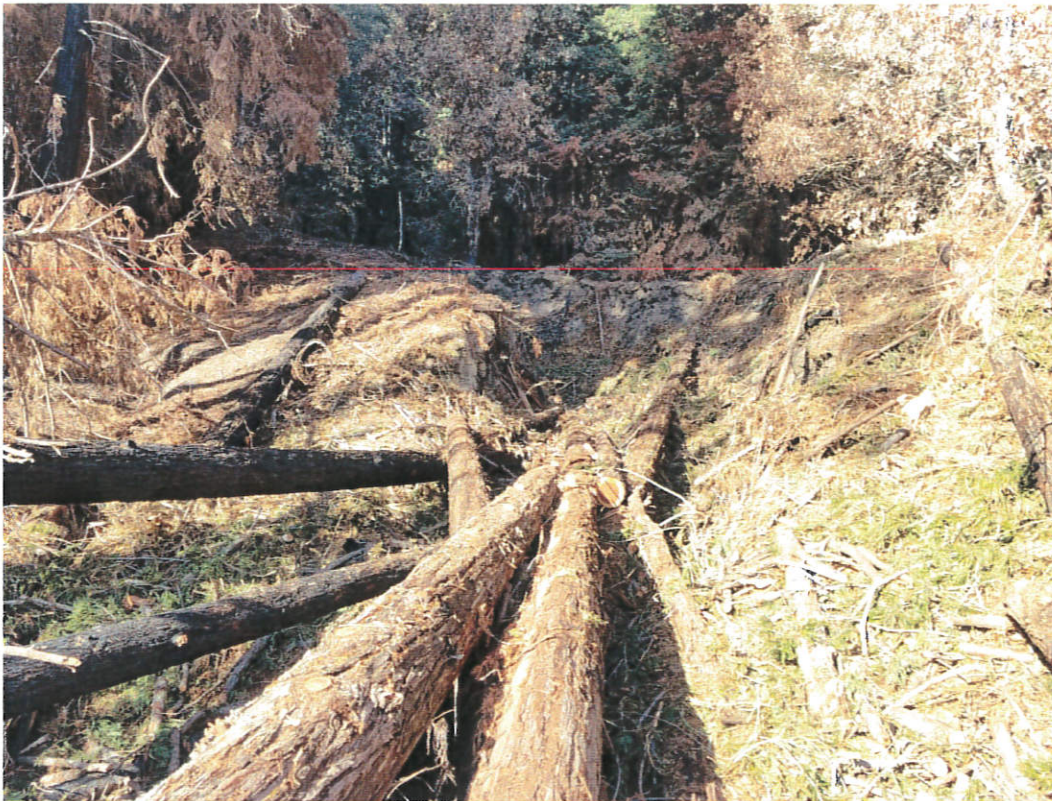
On San Vicente Redwoods property, east of gate 12, at Photo point SB-9, a known unstable area was inspected. The CAL FIRE Forester observed evidence of recently cut redwoods and equipment operations within the unstable area. This is a violation of 14 CCR §§914.2(d).

**Photo taken 11-7-2020 by S. Bullock Photo Point SB-9. Shows unstable area below Gate 12 Road.**
